Home Report

Scottish
Single Survey

Property address	11/18 Simpson Loan Edinburgh EH3 9GP EH3 9GP
Customer	Alasdair Franklin
Customer address	11/18 Simpson Loan Edinburgh
	EH3 9GP EH3 9GP
Prepared by	Shepherd Chartered Surveyors
Date of inspection	17/12/2024

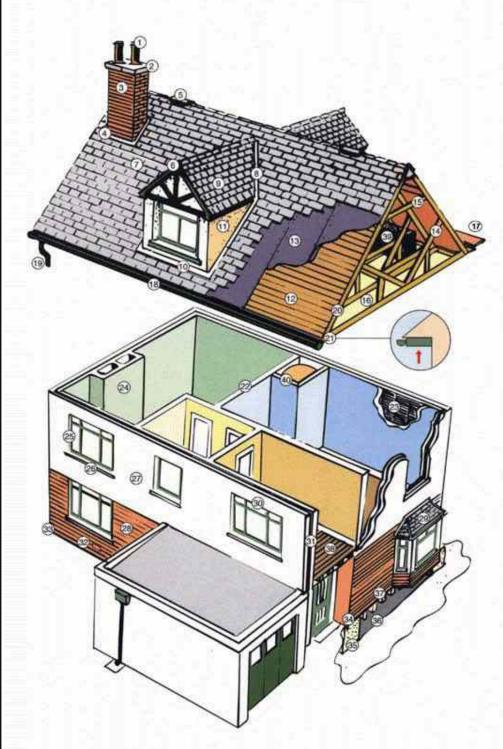
Sectional Diagram showing elements of a typical house

Reference may be made in this report to some or all of the above component parts of the property. This diagram may assist you in locating and understanding these items.

- 1) Chimney pots
- 2) Coping stone
- 3 Chimney head
- (4) Flashing
- 5) Ridge ventilation
- 6 Ridge board
- (7) Slates / tiles
- 8 Valley guttering
- Dormer projection
- 10 Dormer flashing
- 11) Dormer cheeks
- (12) Sarking
- (13) Roof felt
- 14) Trusses
- 15) Collar
- 16) Insulation
- (17) Parapet gutter
- 18) Eaves guttering
- (19) Rainwater downpipe
- 20) Verge boards /skews
- 21) Soffit boards
- 22) Partition wall
- 23) Lath / plaster
- (24) Chimney breast
- 25) Window pointing
- 26) Window sills
- 27) Rendering
- (28) Brickwork / pointing
- (29) Bay window projection
- (30) Lintels
- (31) Cavity walls / wall ties
- 32) Subfloor ventilator
- (33) Damp proof course
- 34) Base course
- 35) Foundations
- 36) Solum
- 37) Floor joists
- 38) Floorboards
- 39) Water tank
- 40) Hot water tank
