Scottish Single Survey

Property address	Mays Cottage 4 Viewforth North Berwick EH39 4JA
------------------	--

Prepared by	Shepherd Chartered Surveyors
-------------	------------------------------

Date of inspection	14/03/2025

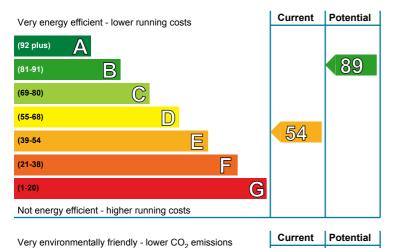
Energy Efficiency Rating

This graph shows the current efficiency of your home, taking into account both energy efficiency and fuel costs. The higher this rating, the lower your fuel bills are likely to be.
