SHEPHERD
HOME REPORT

PF1
7 WESTFIELD STREET
EDINBURGH
EH11 2RB

Energy performance certificate

Scottish Single Survey

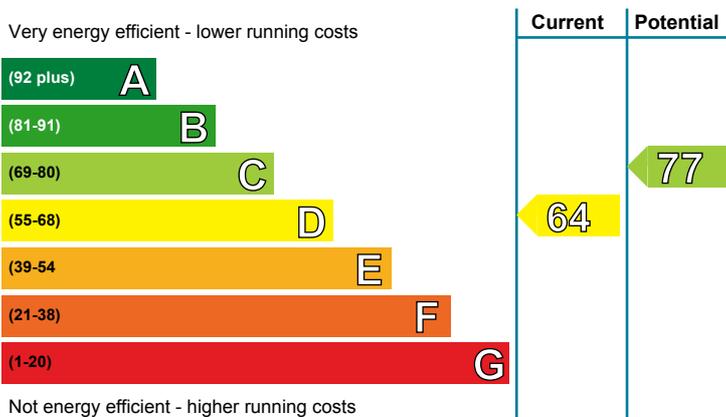
Energy Efficiency Rating

This graph shows the current efficiency of your home, taking into account both energy efficiency and fuel costs. The higher this rating, the lower your fuel bills are likely to be.

Your current rating is **band D (64)**. The average rating for EPCs in Scotland is **band D (61)**.

The potential rating shows the effect of undertaking all of the improvement measures listed within your recommendations report.

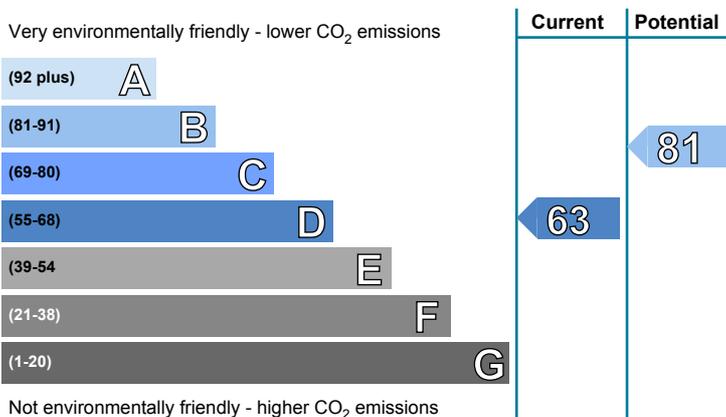
Environmental Impact (CO₂) Rating

This graph shows the effect of your home on the environment in terms of carbon dioxide (CO₂) emissions. The higher the rating, the less impact it has on the environment.

Your current rating is **band D (63)**. The average rating for EPCs in Scotland is **band D (59)**.

The potential rating shows the effect of undertaking all of the improvement measures listed within your recommendations report.

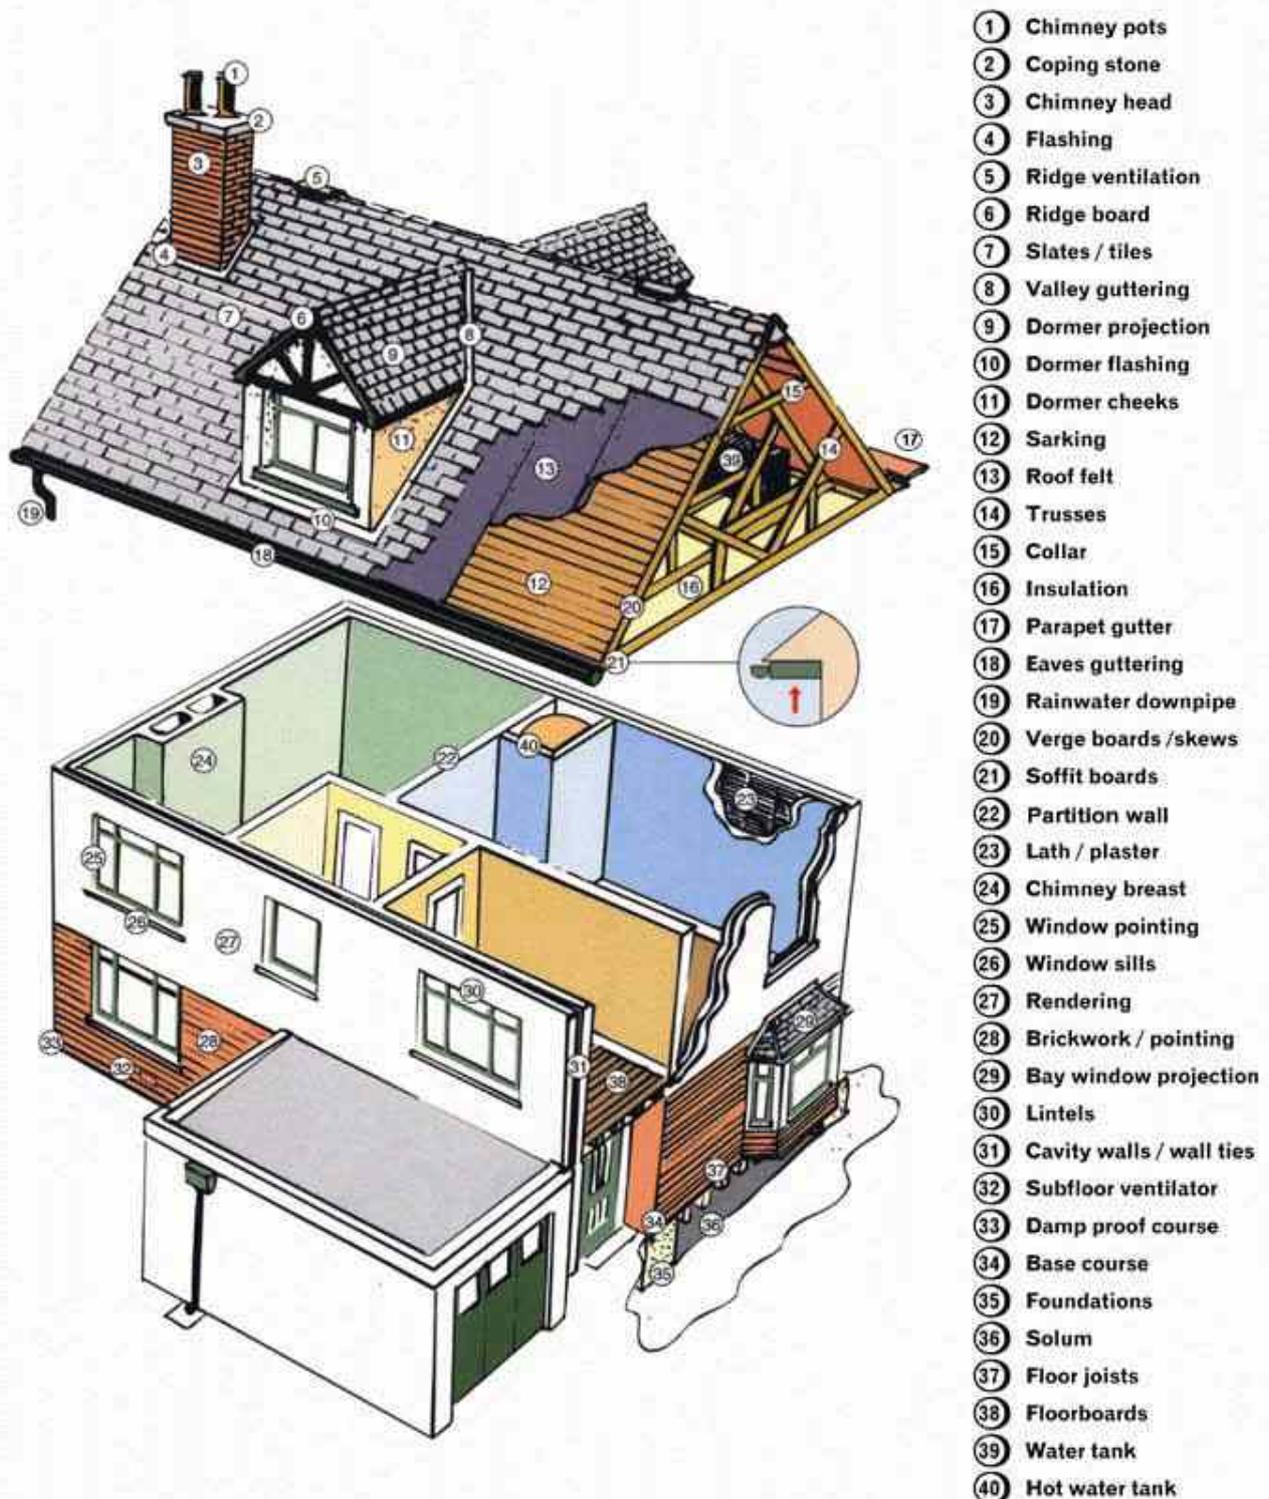
Sectional Diagram showing elements of a typical house

Reference may be made in this report to some or all of the above component parts of the property. This diagram may assist you in locating and understanding these items.
