"THE NATIONAL PROPERTY SERVICE"

FLAT 9 3 HAWTHORNDEN PLACE EDINBURGH EH7 4RF

Energy performance certificate

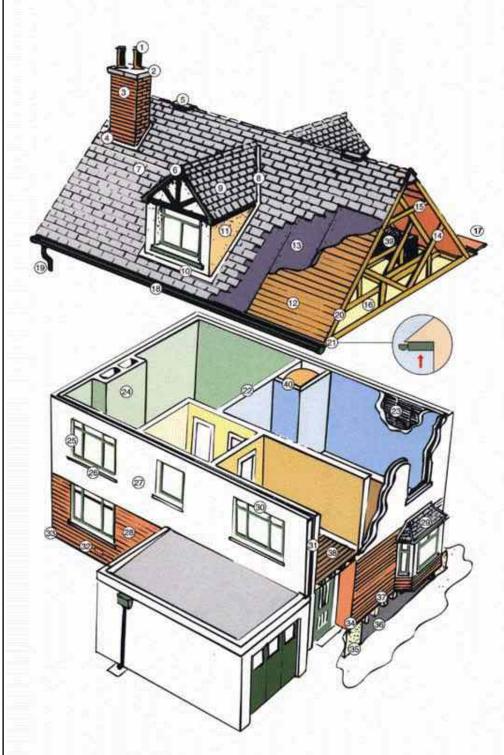
Sectional Diagram showing elements of a typical house

Reference may be made in this report to some or all of the above component parts of the property. This diagram may assist you in locating and understanding these items.

- 1 Chimney pots
- (2) Coping stone
- 3) Chimney head
- 4) Flashing
- (5) Ridge ventilation
- 6) Ridge board
- 7) Slates / tiles
- 8 Valley guttering
- 9) Dormer projection
- 10 Dormer flashing
- 11) Dormer cheeks
- (12) Sarking
- (13) Roof felt
- (14) Trusses
- 15) Collar
- (16) Insulation
- 17) Parapet gutter
- 18) Eaves guttering
- 19) Rainwater downpipe
- 0) Verge boards /skews
- 21) Soffit boards
- 22) Partition wall
- 23) Lath / plaster
- 24) Chimney breast
- (25) Window pointing
- S
- (26) Window sills
- (27) Rendering
- 28) Brickwork / pointing
- 29) Bay window projection
- (30) Lintels
- (31) Cavity walls / wall ties
- 32) Subfloor ventilator
- 33) Damp proof course
- 34) Base course
- 35) Foundations
- 36) Solum
- 37) Floor joists
- 38) Floorboards
- Water tank
- 10) Hot water tank
